TROUBLESHOOTING

Percussion Drill Bit

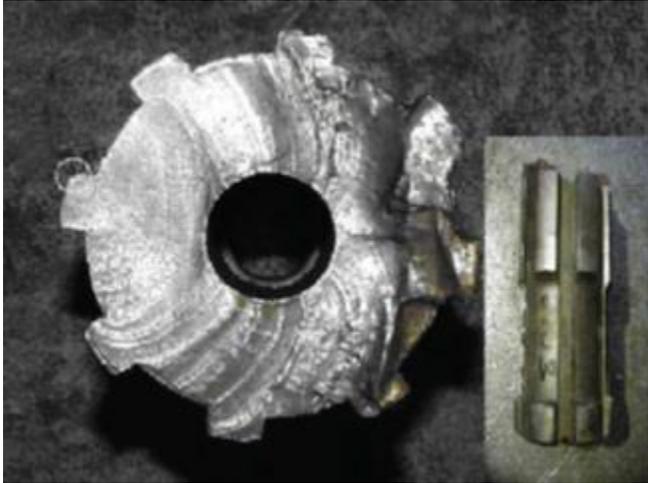
The contact area generally appears as a bright smooth surface. However, when viewed through a magnifying lens small very fine transverse cracks can be seen. Under the vibrating conditions of the drilling operation one or more of these cracks may grow as a fatigue fracture, ultimately causing catastrophic failure – shanking – see Figure 5.

FIGURE 5 - Bit spline fracture

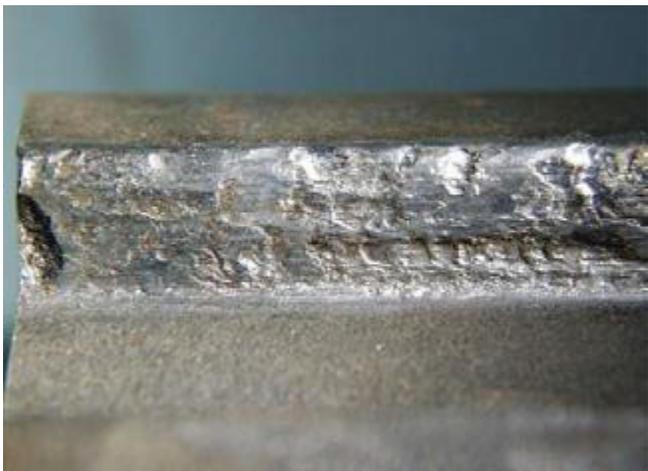
Excessive weight on bit, running large wear flats on buttons; and the usage of too large a diameter head to bit shank diameter are all factors which develop very high rotational torque levels. These conditions cause massive galling on the spline thrust face, as shown in Figure 6, with associated heat check cracking. As in the subsequent growth of a fatigue crack will cause shanking.

FIGURE 6 - Bit failure due to spline galling

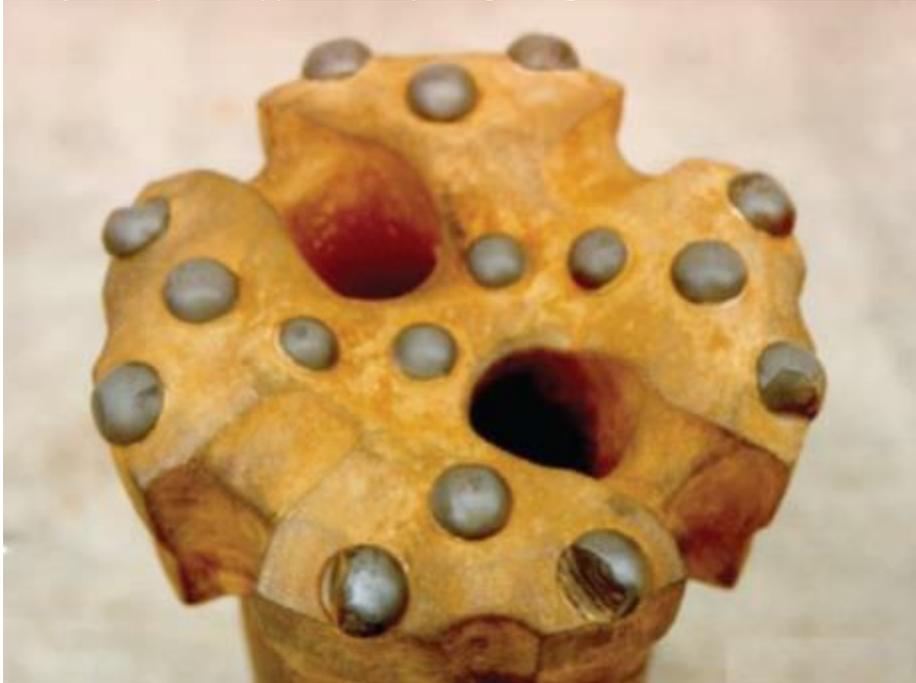
The tell-tale evidence that a button has failed by stress overloading is the resultant 'cusp' fracture. That is, on the fracture surface a small peak forms diametrically across the button and always in a plane, approximately at right angles to the direction of bit rotation. See Figure 17.

FIGURE 17 - Example of button with "Cusp" failure

The sequence of a 'stress overload' failure is that generally the trailing section of the button domes will break away first followed by fracture of the leading section, as shown in Figure 18. The characteristics of the load (stress) planes that occur during the failure process are such that an upward cusp fracture pattern results.

- Reduction and control of weight on bit,
- Increase of rotation speed slightly, particularly if there is evidence of wear on the leading side of the button
- Frequent sharpening to restore the original button profile

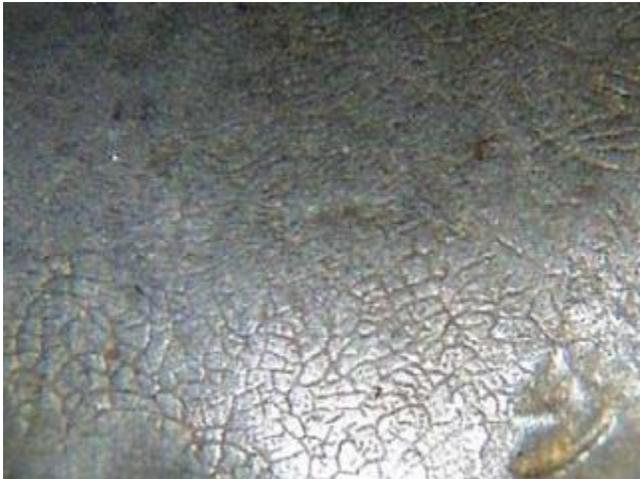
Its development is due to the contact area of the button becoming fatigued from the dual action of cyclic impact stress application and thermal stressing. A network of fine very shallow cracks appear which resemble a snake's skin and for most times, require a magnifying lens to clearly detect, see Figure 19.

If snake skin cracking is allowed to remain, continued working of the bit can cause the cracks to grow deeper and eventually cause catastrophic failure. The resultant fracture displays a multifaceted surface. Failure can be prevented /minimised by more frequent grinding of the buttons to remove the cracked skin.

FIGURE 19 - Snake skin on tungsten carbide button surface

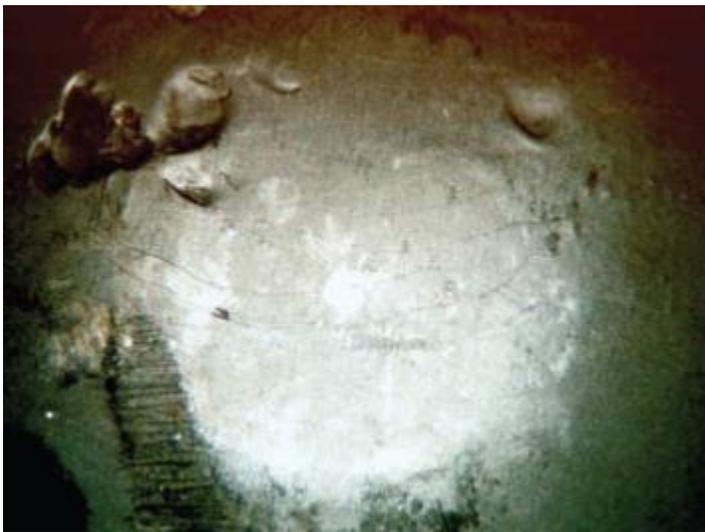
Thermal shock cracking develops from the generation of excessive and sustained frictional heating as the carbide button slide against the rock surface in the hole. High hardness, fine grained rock appears to influence this type of cracking.

Cracking generally takes the form of sweeping arcs across the wear/contact zone and often with associated surface chipping, see Figure 20. Like snake skin cracking, crack growth can lead to multifaceted catastrophic failure. Thermal cracking can be prevented /minimised by slower rotation speed, lower weight on bit and the use of a tougher (softer) grade of carbide.

FIGURE 20 - Thermal cracking on tungsten carbide button surface

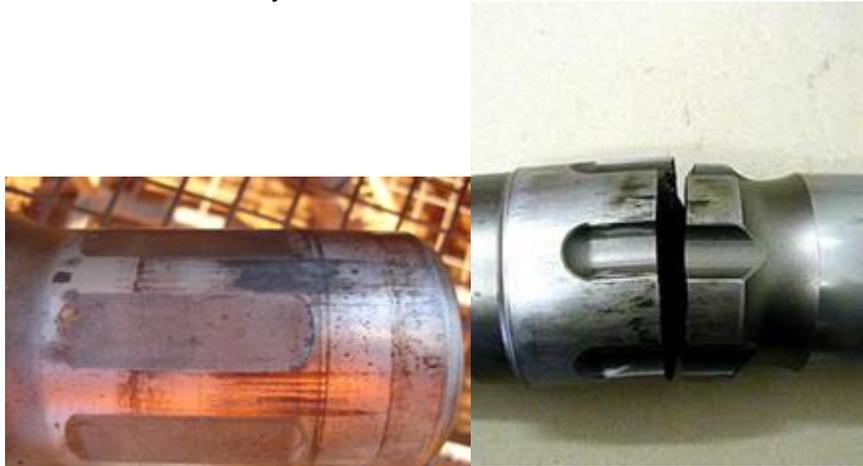
The most common failure zone of a piston is through its bearing areas. The photograph clearly shows surface galling and associated heat tinting at the point of fracture origin.

The fundamental cause of this type of failure is due to 'loss of lubrication'. What we mean by loss of lubrication is the loss or break down of the oil 'wedge', which keeps the piston separated from the cylinder or sleeve bore. Obviously, when this occurs metal to metal contact results and thus the generation of frictional heat and possibly galling.

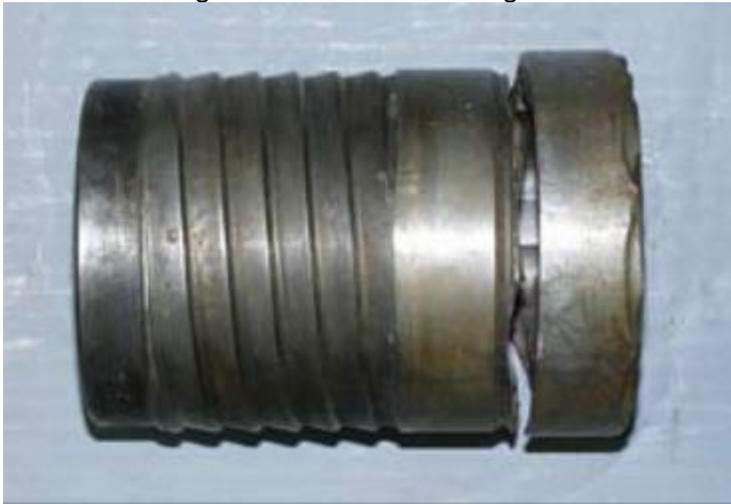
The fracture surface displays a brittle 'crystalline' structure with its characteristic 'arrow head' markings directing back to the point of fracture origin. Refer Figure 7.

Brittle fracture propagates as an instantaneous break, and is due to a sudden stress overload, influenced by the 'notch' effect of the change of cross section.

This type of failure results from a loose joint which can occur when hammering without rotation, Insufficient weight on bit or when drilling soft and unconsolidated ground.

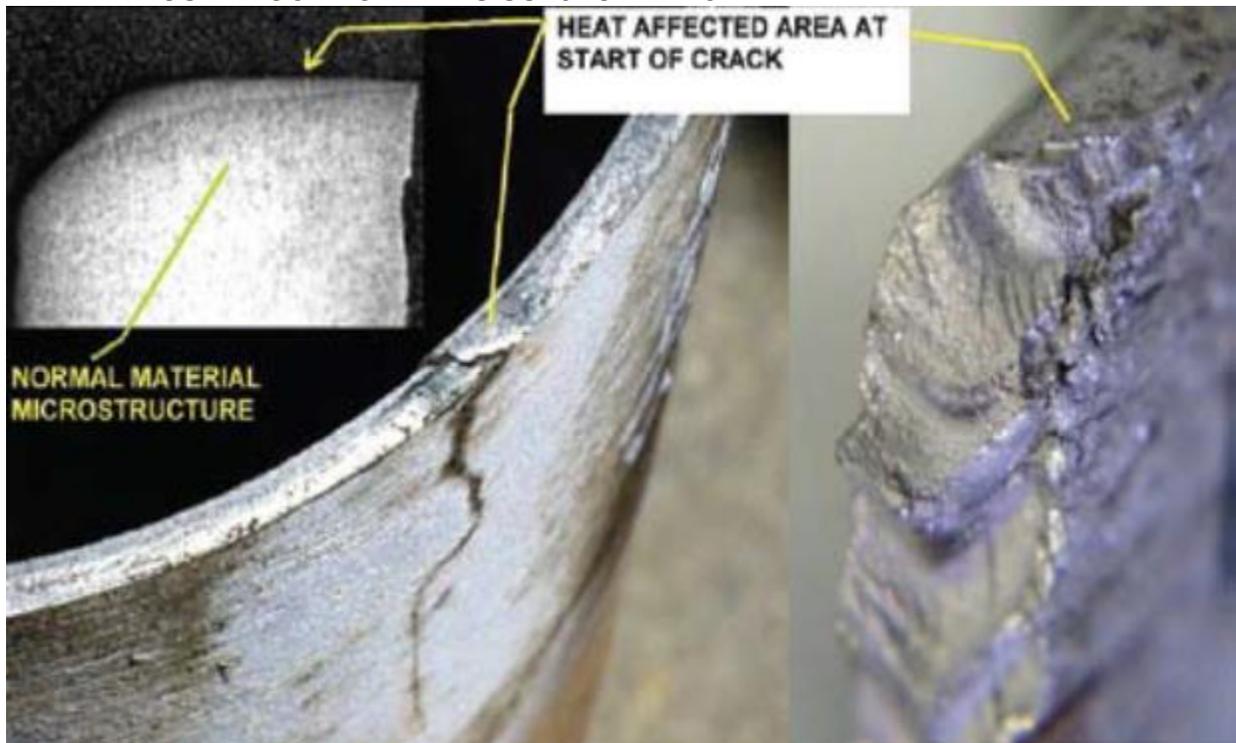
Cases of heat check cracking have been found on the thread profile (drive sub end) of cylinders. The basic cause has been the practice of poor alignment of the drive sub to cylinder, the use of too high rig rotation speed when tightening drive sub, and probably insufficient quantity of grease lubricant.

Another related example is when drillers use the rig to align and assemble the cylinder onto the drive sub. Instances can occur where the cylinder end face engages and rotates on the strike face of the bit or the top edge of the drive sub, thus creating considerable frictional heat and hence subsequent heat check cracking. Figure 8 is a photographic record of this type of failure.

FIGURE 8 - Cylinder failure

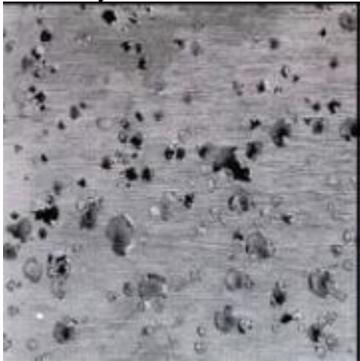
(A) severe deep pits

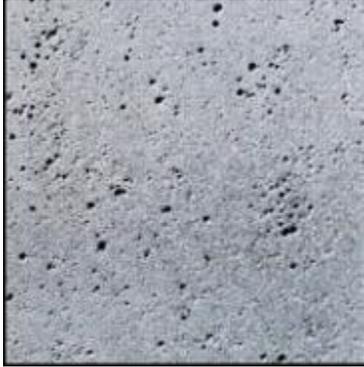
(B) shallow pits

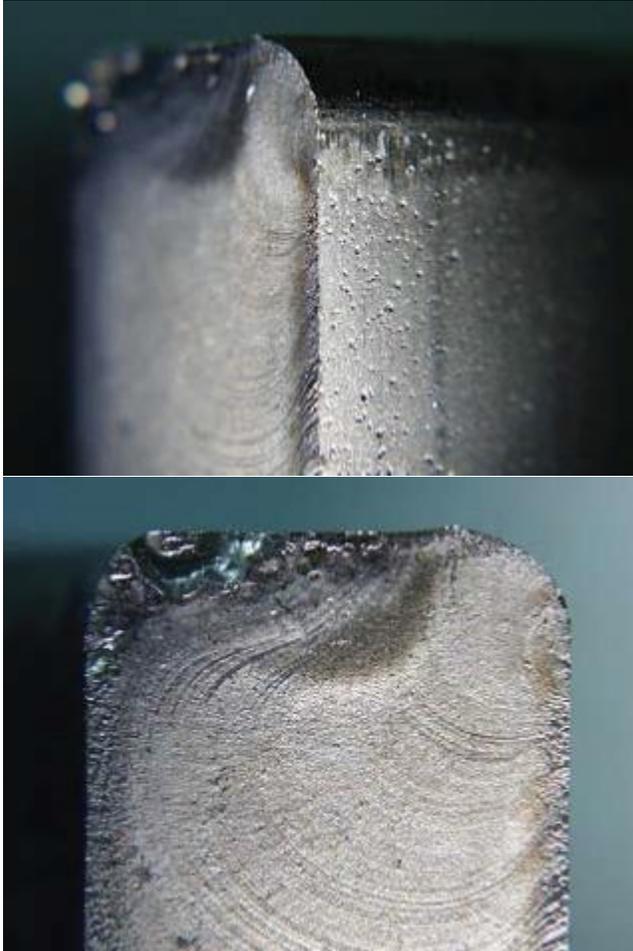
This phenomenon is common to drilling equipment and its effects are catastrophic. There are known cases where pitting corrosion on a piston nose has resulted in the top section of the piston breaking off after servicing only 20% of average expected life. Similarly with cylinders, circumferential cracking at the drive sub end thread has been known to develop after 1,000 to 2,000 metres of drilling.

Figures 10, 11 and 12 are examples of premature failure of a piston, cylinder and drill bit. It should be emphasised that corrosion attack on drilling equipment can be controlled and thereby premature failures minimised by regular maintenance of protective barriers and the adherence to correct procedure for 'Parking' and/or 'Storage' of hammers and bits.

FIGURE 10 - Piston failure by corrosion
