TROUBLESHOOTING

Percussion Drill Bit

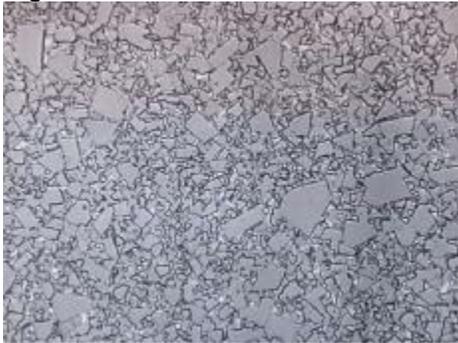
FIGURE 16 - Micrograph of tungsten carbide button

The tungsten carbide is in the form of very small and varied size grains while the cobalt is the matrix which during manufacture has melted, flowed and enveloped the tungsten grains, see Figure 16.

The tungsten carbide is extremely hard, brittle and wear resistant whereas the cobalt is relatively soft and tough. The general rule of thumb is, the harder the button the less tough it is and therefore more prone to breakage. The softer the button the more tough it is but more susceptible to wear. Increasing tungsten carbide grain size will also effectively increase the button's toughness properties

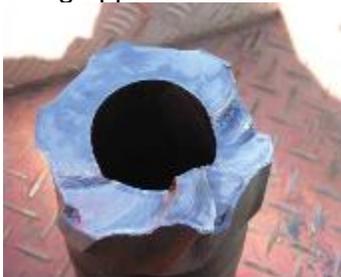
A fatigue fracture is readily identified by its conchoidal growth rings, often called 'beach markings' which radiate out from the crack origin. The beach markings develop from the arrest and propagation of the crack. Its rate of growth can vary considerably depending on the loading being applied.

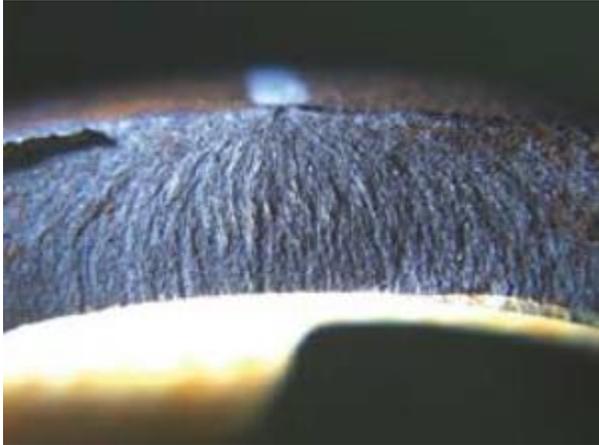
Brittle fracture results from a stress overload, facilitated by a stress concentrator such as a sharp corner or a change in diameter/cross section.

Brittle fracture is instantaneous in its action as it propagates at many thousands of feet per second.
